**Summary of Geotechnical Investigation and
Pit Slope Stability Assessment
Maria Pit Expansion**

October 2015

CS Mining
PO Box 608
1208 South 200 West
Milford, Utah 84751

Cardno, Inc.
534 Bluefield Industrial Park
Bluefield, Virginia 24605
www.cardno.com

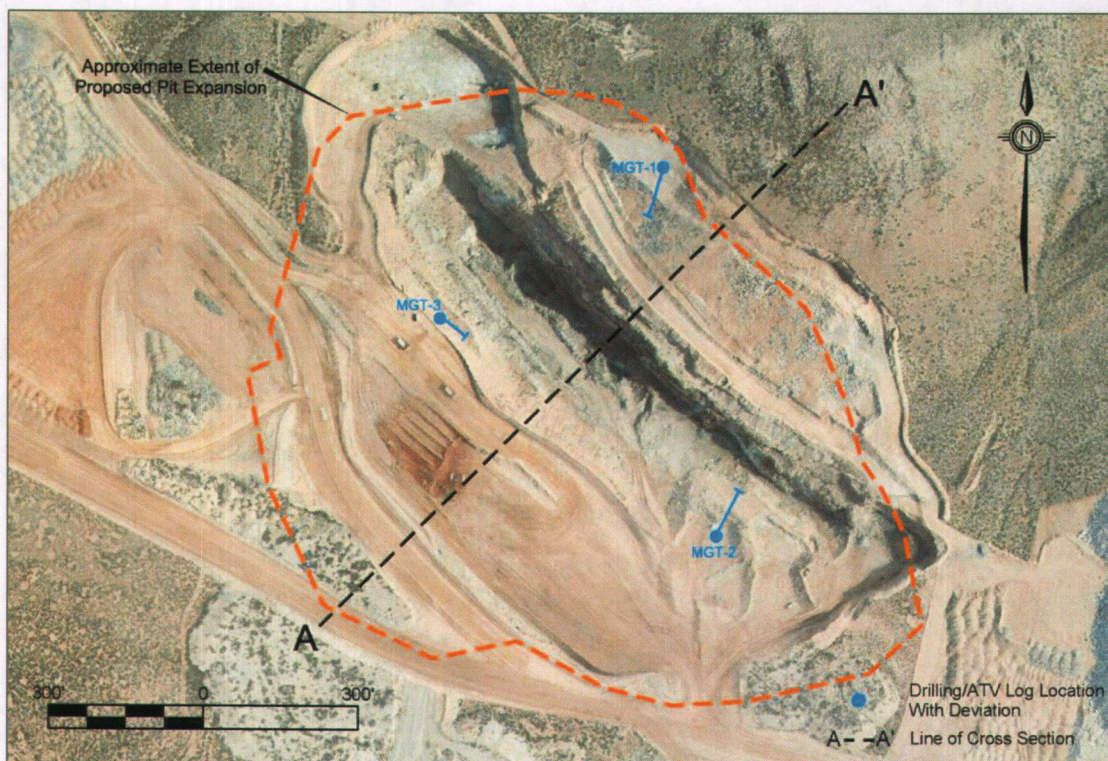
Figure 2-2: Existing Maria Pit with Cross Section Line and Exploration Hole Locations

The Maria Pit is located approximately four miles northwest of Milford, Utah (see *Figure 2-1*). The existing Maria Pit and the approximate extent of the proposed pit expansion area are indicated in *Figure 2-2*. The pit area lies in the Rocky Range Mining District within a belt of altered granite to diorite intrusive rocks, and the Maria deposit is classified as a skarn copper-gold-tungsten-molybdenum type deposit. The ore zones of the Maria copper deposit are found in metasedimentary rocks located between sills or other bodies of quartz monzonite. A general geologic cross section is presented in *Figure 2-3*.
